EXHIBIT No. 5

ARCCA, INCORPORATED
2288 SECOND STREET PIKE
PO BOX 78 · PENNS PARK, PA 18943-0078
PHONE 215-598-9750 · FAX 215-598-9751
WWW.ARCCA.COM

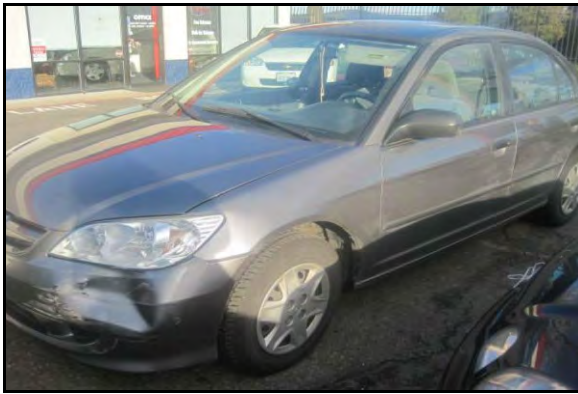
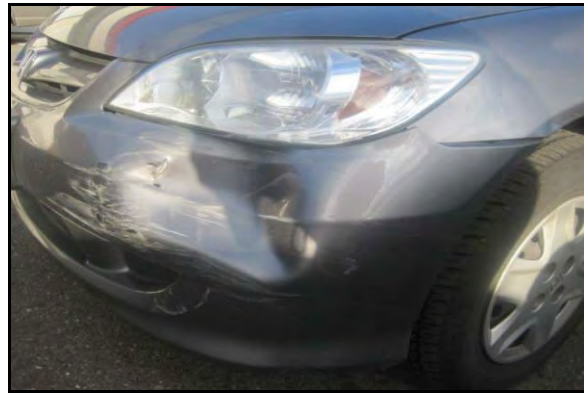
The damage estimate of the subject Honda Civic indicated damage primarily to the left lens and housing, impact bar, left stiffener, bumper cover, front retainers, hood, left fender, left side support, left side panel, upper tie bar, and required a frame pull; which is consistent with the reviewed photographic reproductions (Figure 1). The damage estimate of the incident Chevrolet Lumina indicated damage primarily to the left fender, left door assembly, left mirror assembly, left body side molding, left handle, and the left uniside assembly; which is consistent with the reviewed photographic reproductions (Figure 2).

Figure 1: Reproductions of the subject 2005 Honda Civic

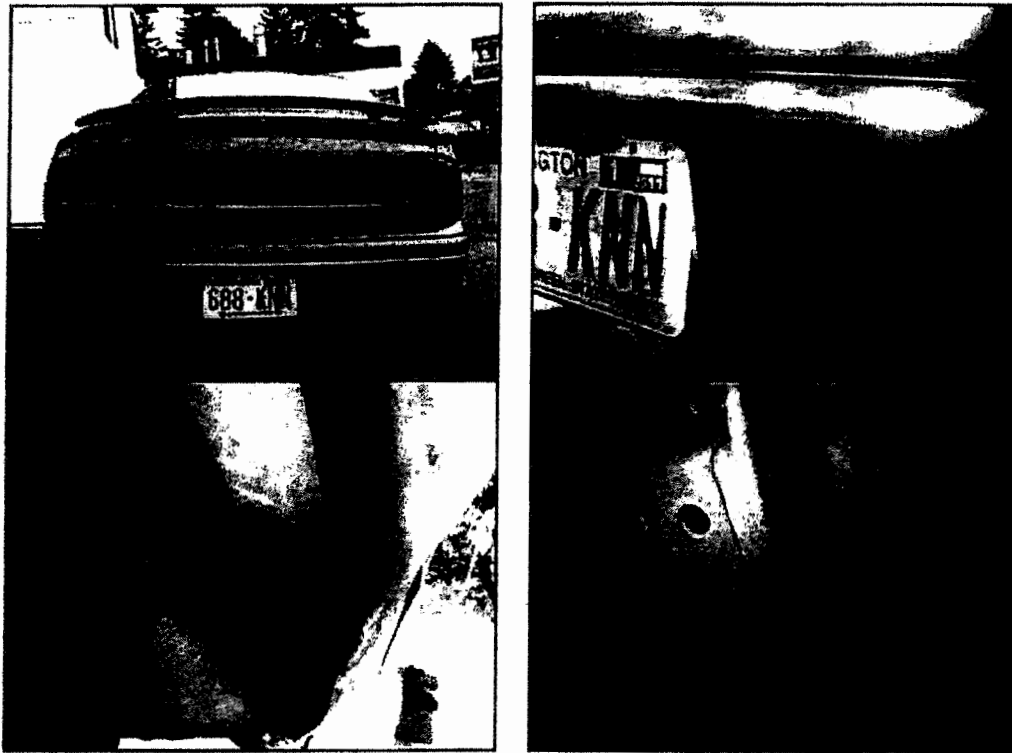
The damage estimate of the subject Dodge Neon indicated damage primarily to the rear bumper cover, which is consistent with the reviewed photographic reproductions (Figure 1). The reviewed photographic reproductions of the incident Hyundai depicted damage to the license plate (Figure 2). Additionally, the State of Washington Police Traffic Collision Report indicated there was no visible damage to either vehicle.

Figure 1: Reproductions of photographs of the subject 1998 Dodge Neon

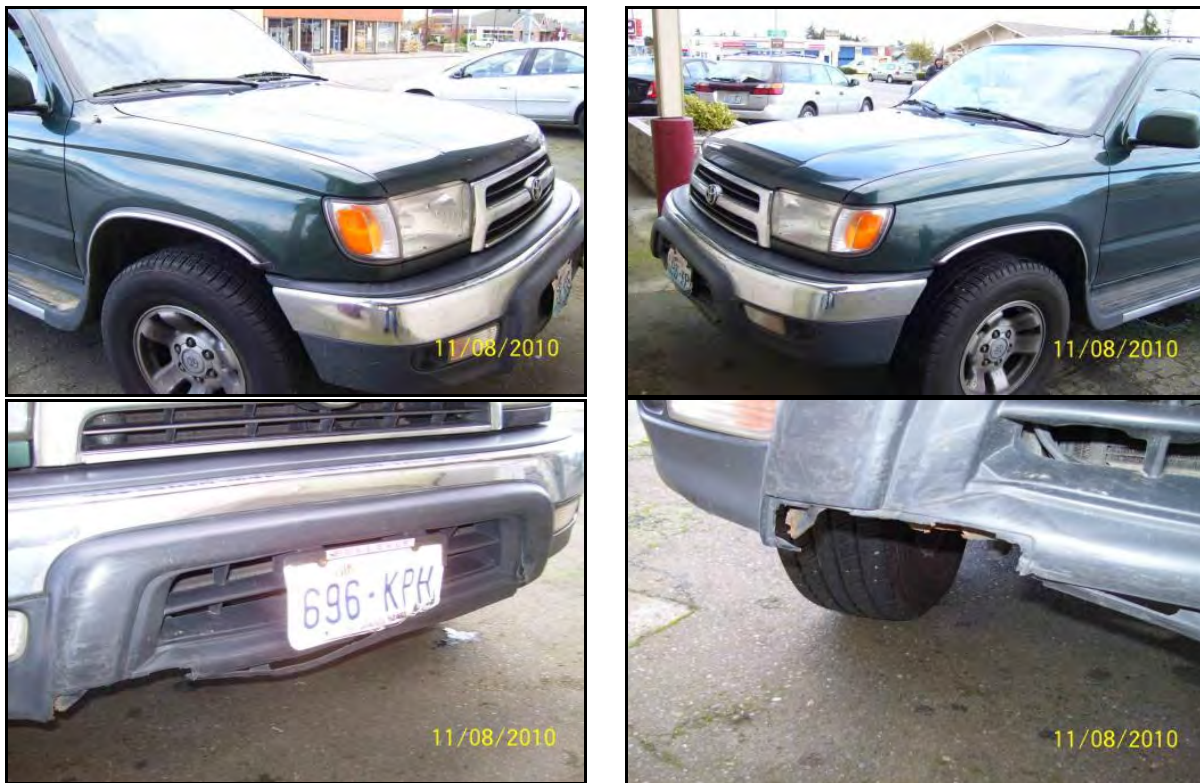
The damage estimate of the subject Toyota 4Runner indicated damage primarily to the front bumper valance, face bar, and front bumper plate; which is consistent with the photographic reproductions of the subject Toyota (Figure 1). The damage estimate of the incident Subaru Forester indicated damage primarily to the front bumper cover, right headlamp assembly, right fender, right fender extension, right fender liner, right lower frame, right side wheels, right control arm, right axle assembly, right inner tie rod, right outer tie rod, right front door shell, right molding assembly, right mirror assembly, right rear door shell, right quarter panel, right quarter glass, and rear bumper cover; which is consistent with the photographic reproductions of the incident Subaru (Figure 2). Note: all the damage to the incident Subaru is not due to contact with the subject Toyota. After contacting the subject Toyota the Subaru continued to strike a curb.

Figure 1: Reproductions of the subject 2000 Toyota 4Runner

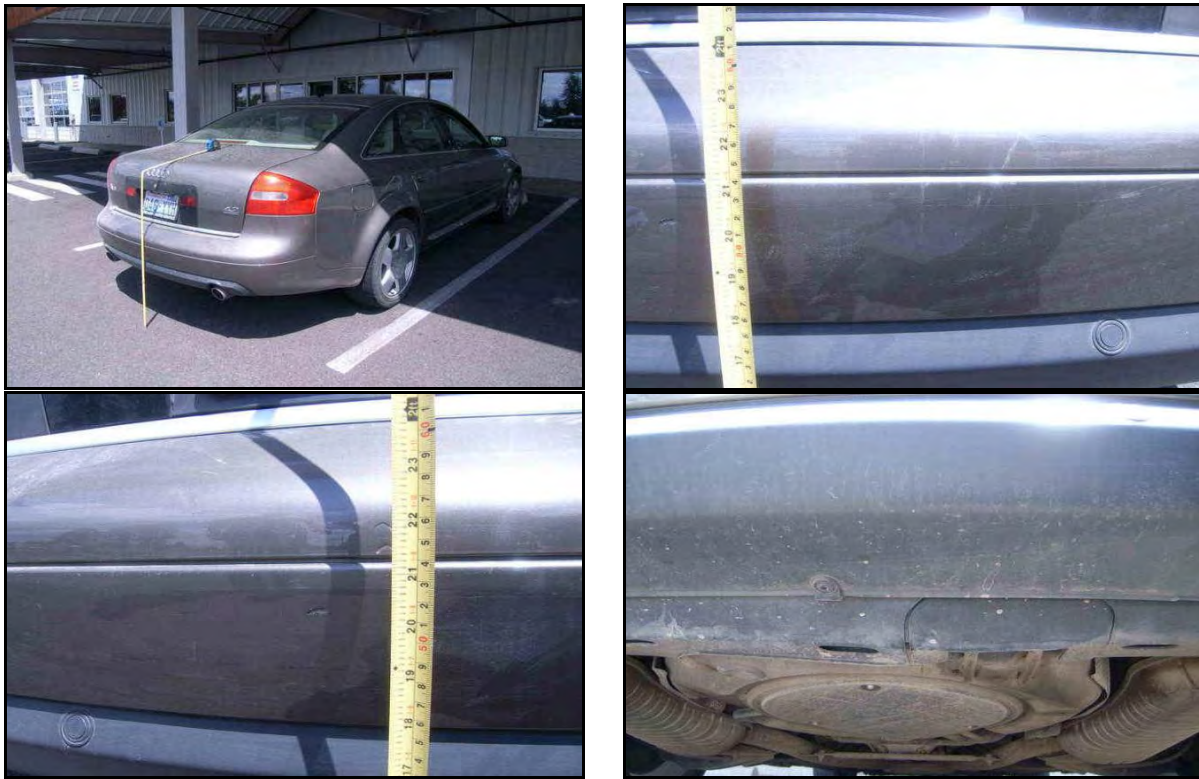
The damage estimate of the subject Audi indicated damage primarily to the rear bumper cover; which is consistent with the reviewed photographic reproductions (Figure 1). The reviewed photographic reproductions of the incident Toyota depicted damage to the license plate and license plate holder (Figure 2).

Figure 1: Reproductions of photographs of the subject 2003 Audi A6

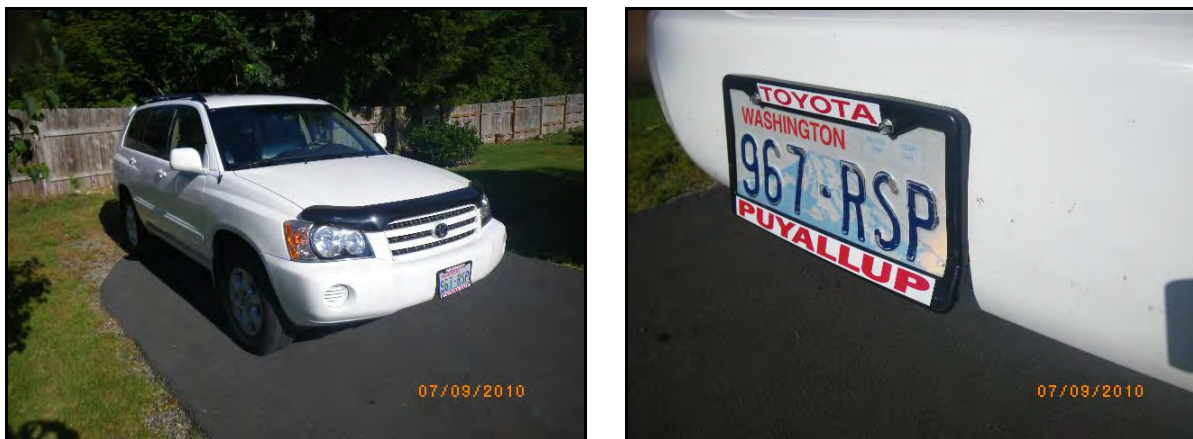
Figure 2: Reproductions of photographs of the incident 2003 Toyota Highlander

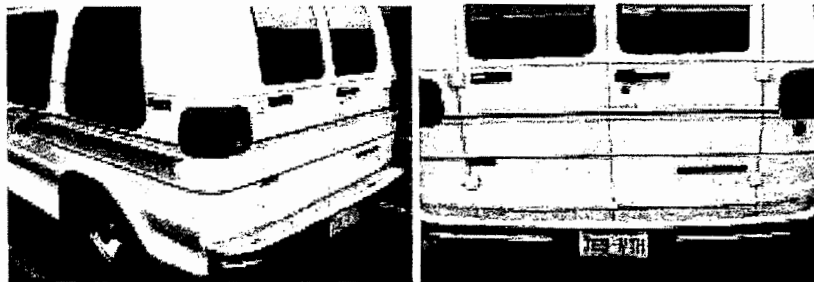
The damage estimate of the subject Dodge B1500 indicated damage primarily to the rear bumper and right side corner panel; which is consistent with the reviewed photographic reproductions (Figure 1).

Figure 1: Reproductions of photographs of the subject 1999 Dodge B1500

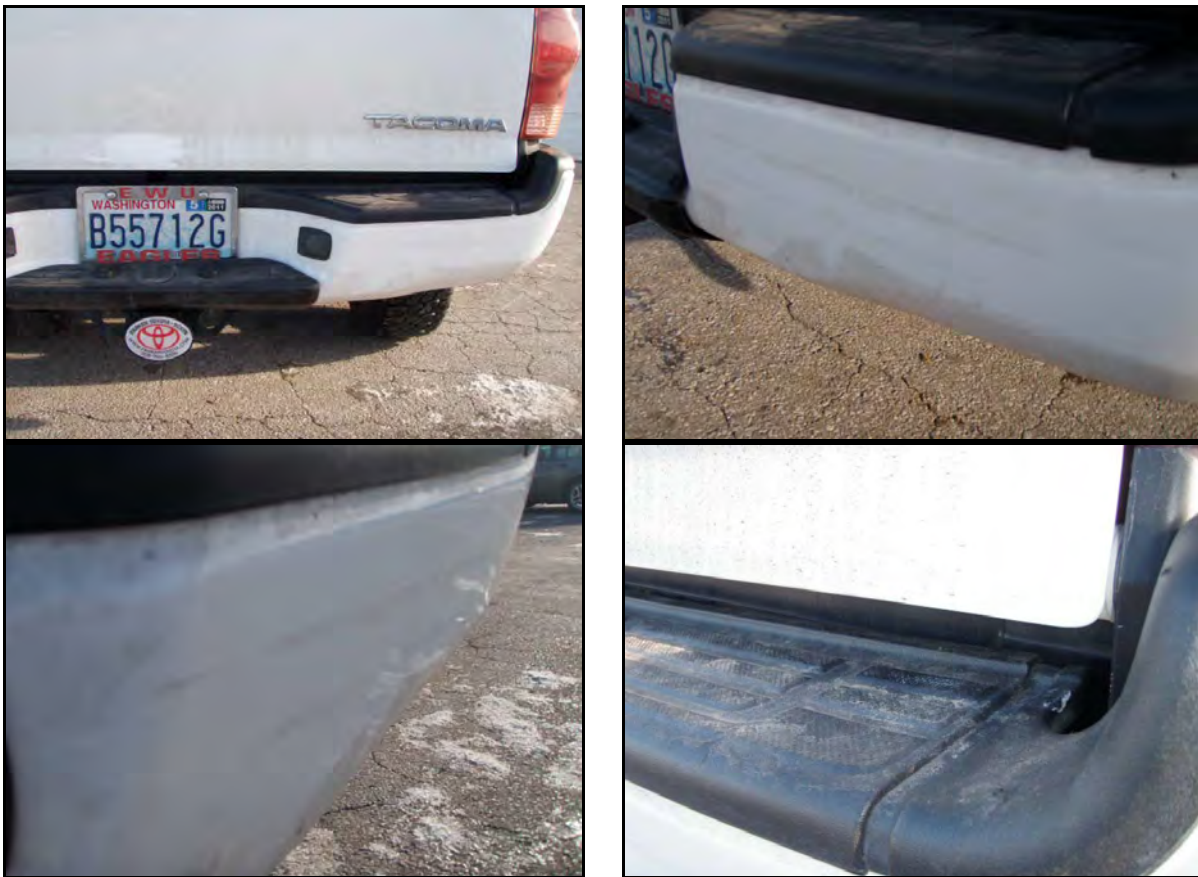
The damage estimate of the subject Toyota Tacoma indicated damage primarily to the rear face bar, right step pad extension, rear cover, right side inner plate, and right corner reinforcement; which is consistent with the reviewed photographic reproductions (Figure 1). Mr. Lynds testified the damage to the subject Toyota was to the tow hitch along with the rear bumper hanging down and creased. The damage estimate of the incident Honda CRV indicated damage primarily to the front license frame; which is consistent with the reviewed photographic reproductions (Figure 2). Additionally, Mr. Lynds testified the damage to the incident Honda was to the front bumper.

Figure 1: Reproductions of photographs of the subject 2006 Toyota Tacoma

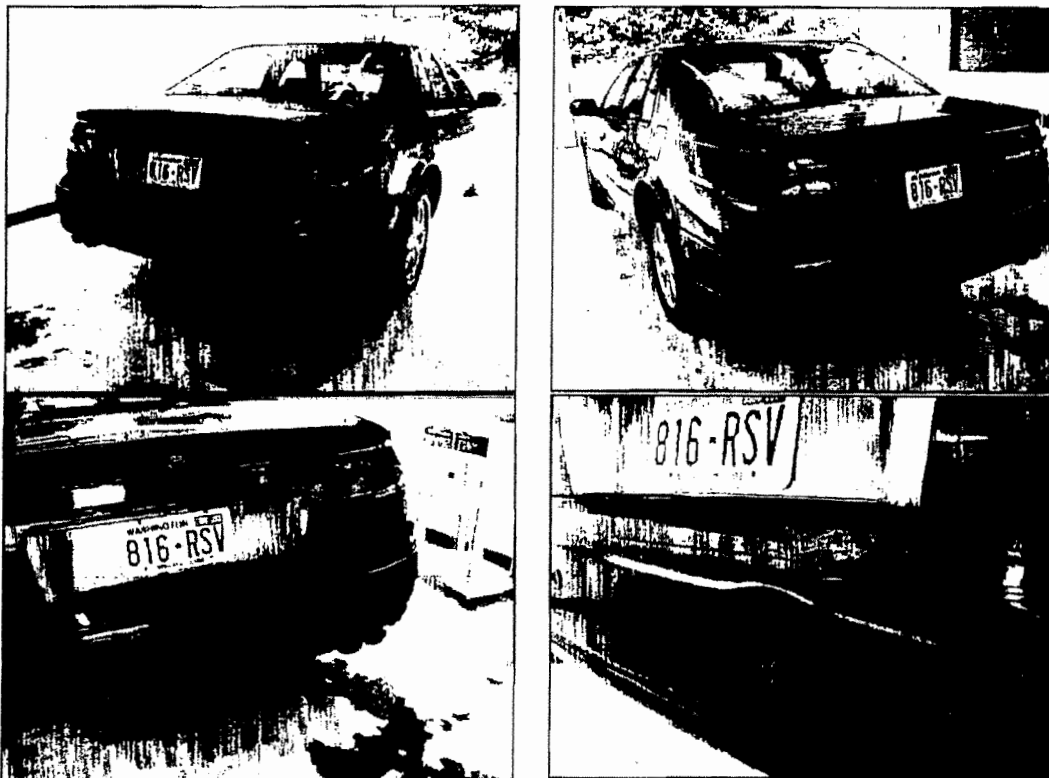
The damage estimate of the subject Cadillac Seville indicated damage primarily to the rear bumper cover; which is consistent with the reviewed photographic reproductions (Figure 1). Mr. Jones testified the damage to the subject Cadillac consisted of a hole pushed in the bumper and paint chipping. Ms. Ong testified that she did not see any damage to the subject Cadillac and there were two small scratches on the incident Mitsubishi due to the subject incident.

Figure 1: Reproductions of photographs of the subject 2004 Cadillac Seville

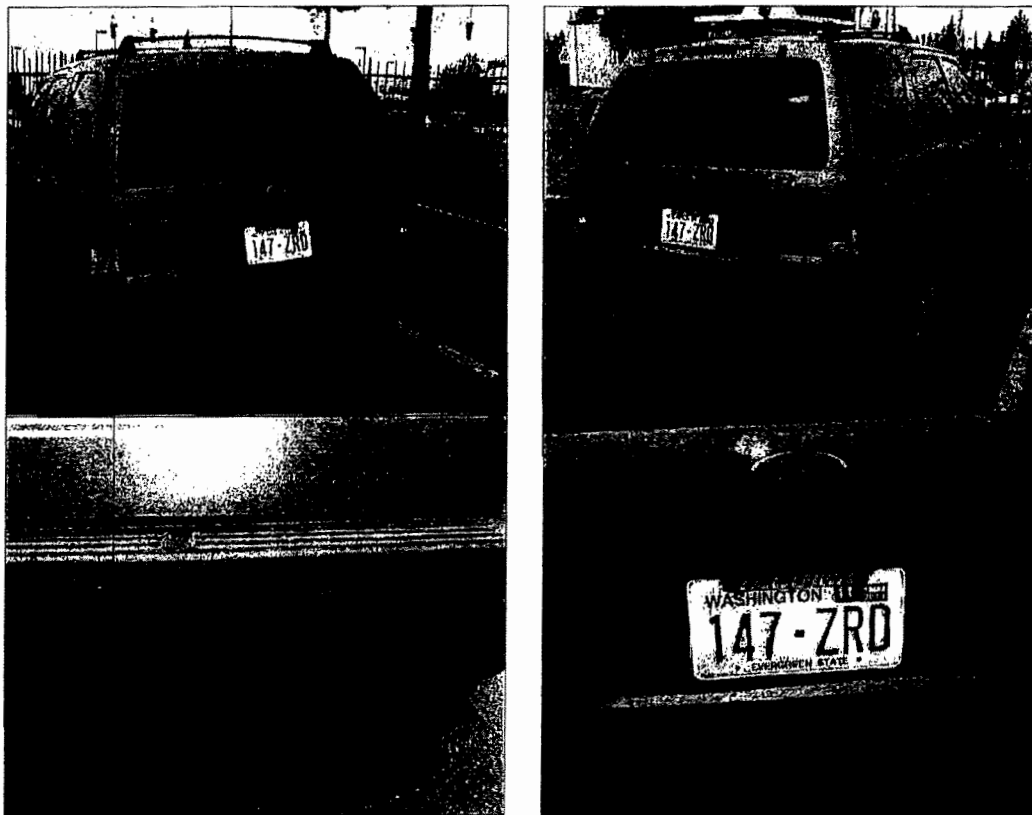
The damage estimate of the subject Ford Escape indicated damage primarily to the rear bumper cover; which is consistent with the reviewed photographic reproductions (Figure 1). The reviewed photographic reproductions of the incident Toyota 4Runner depict minor to no damage (Figure 2).

Figure 1: Reproductions of the subject 2003 Ford Escape

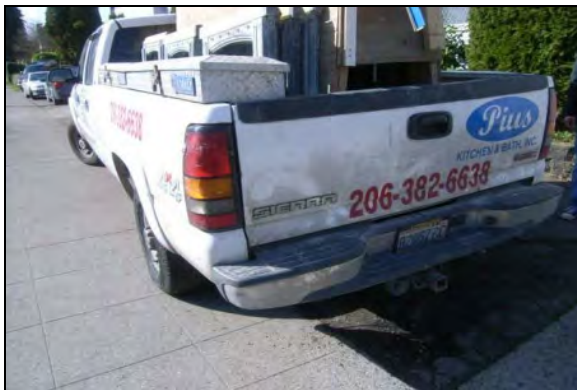
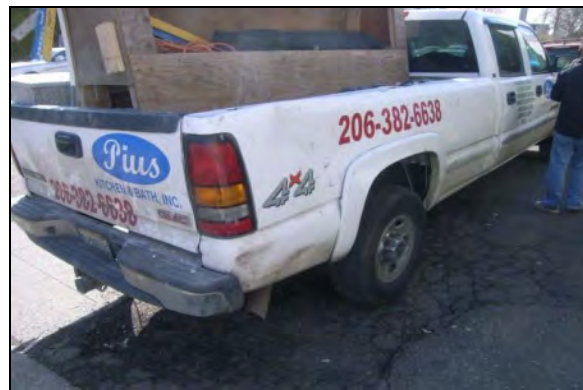
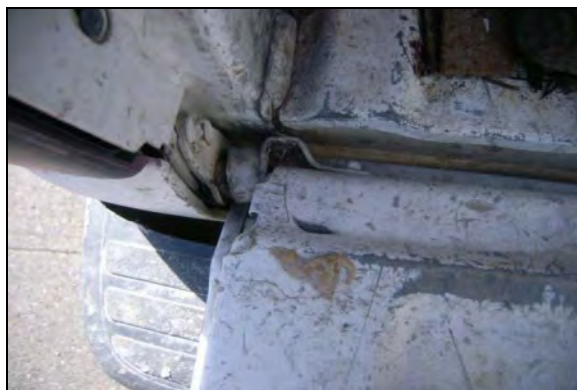
The damage estimate of the subject GMC Sierra indicated damage primarily to the left hinge bed side and left hinge gate side; which is consistent with the reviewed photographic reproductions (Figure 1). The supplemental damage estimate of the incident Lexus RX330 indicated damage primarily to the front bumper cover, right side support, right and left front bumper cover bracket, right headlamp assembly, left upper inner headlamp bracket, radiator upper tie bar, radiator right and left side support, radiator lock support, radiator right deflector, radiator, shroud, A/C condenser, hood, lock, safety catch, grille, right hinge, right fender assembly and low/high note horn; which is consistent with the reviewed photographic reproductions (Figure 2).

Figure 1: Reproductions of photographs of the subject 2007 GMC Sierra

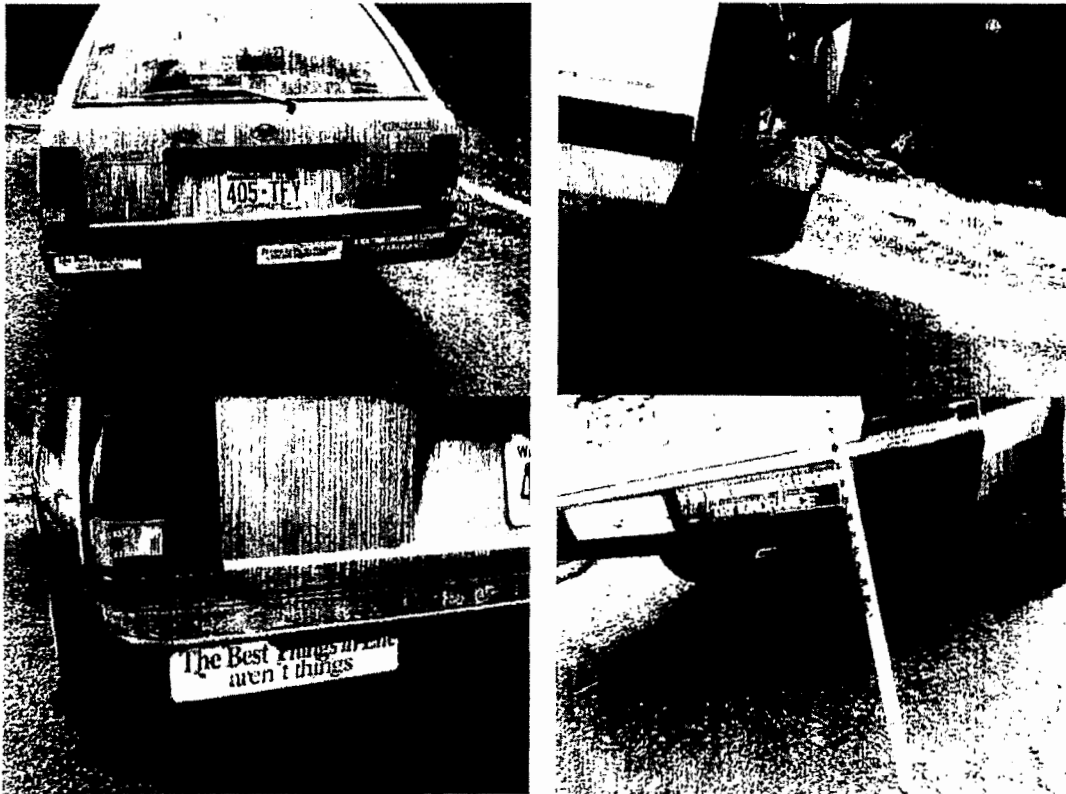
The damage estimate of the subject Subaru Loyale indicated damage primarily to the rear bumper cover and rear bumper components; which is consistent with the reviewed photographic reproductions (Figure 1). Additionally, according to Mr. Kurek's statement, there was no noticeable damage to the incident Toyota.

Figure 1: Reproductions of photographs of the subject 1990 Subaru Loyale

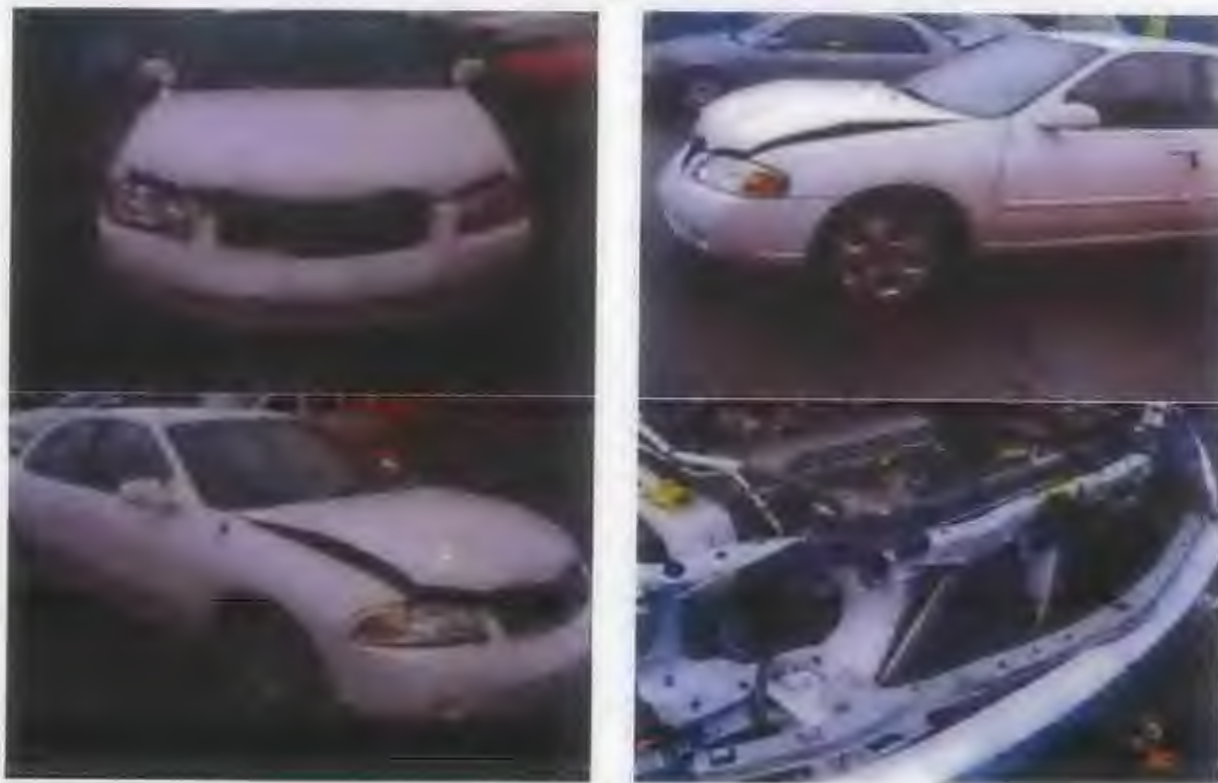
the reviewed photographic reproductions (Figure 1). The damage estimate of the incident Nissan Sentra indicated damage primarily to the front bumper cover, energy absorber, upper retainer, right retaining bracket, right stay bracket, grille assembly, left and right headlamp assembly, radiator support, hood, right fender, and right front wheel cover; which is consistent with the reviewed photographic reproductions (Figure 2).

Figure 2: Reproductions of the incident 2004 Nissan Sentra

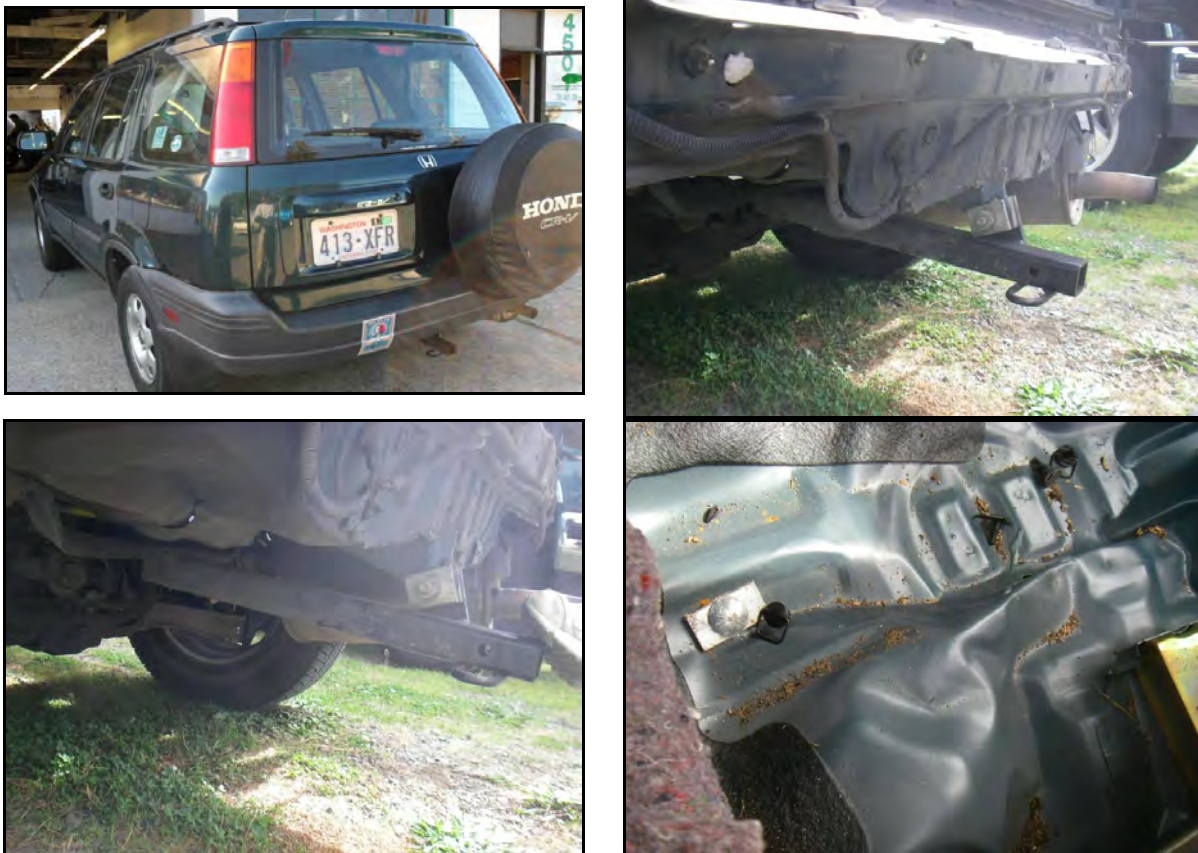
The damage estimate of the subject Honda CRV indicated damage primarily to the rear door, spare cover, rear spare bracket, rear bumper cover, rear body panel, rear floor pan, tow hitch, frame set up and pull to rear floor pan and body panel; which is consistent with the reviewed photographic reproduction (Figure 1).

Figure 1: Reproductions of photographs of the subject 1998 Honda CRV

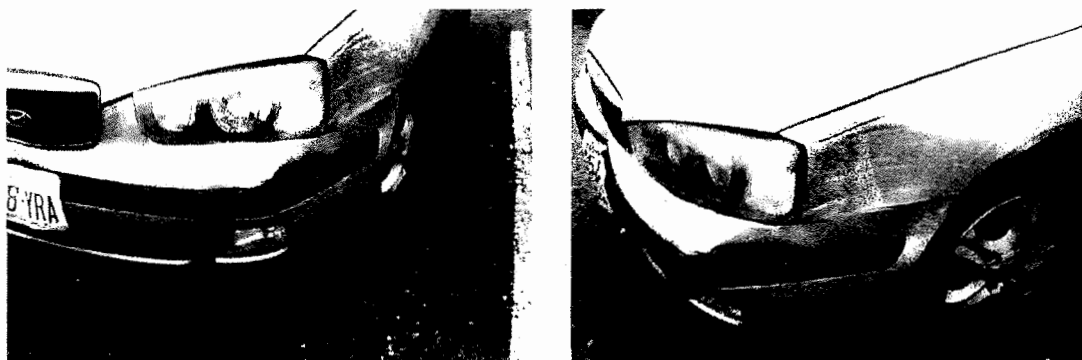
The damage estimate of the subject Subaru Outback indicated damage primarily to the rear bumper cover, trailer hitch, left and right muffler hanger, and the rear bumper required an overhaul; this is consistent with the reviewed photographic reproductions (Figure 1) According to Ms. Wolf's testimony, the hitch had taken the impact. The photographs of the incident Hyundai Elantra indicated damage to the center of the front bumper (Figure 2).

Figure 2: Reproductions of photographs of the incident Hyundai Elantra

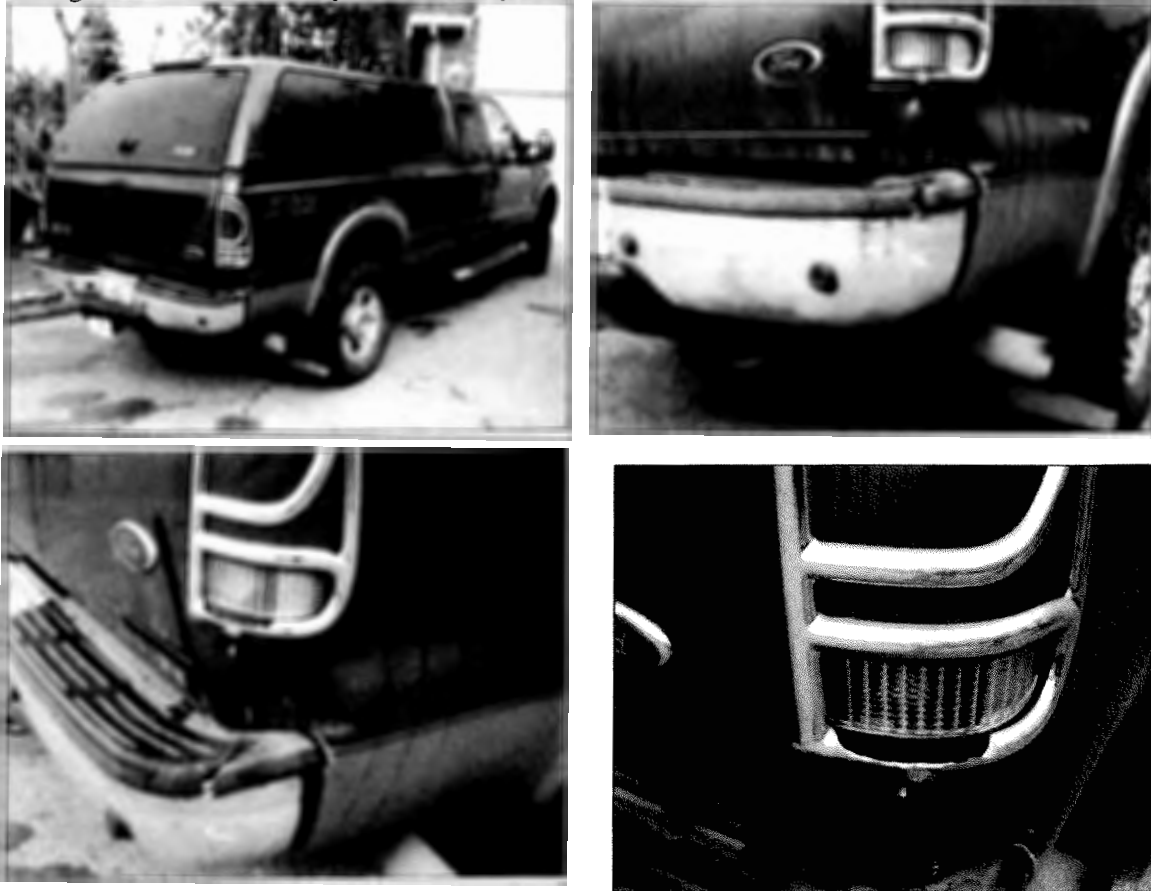
The damage estimate of the subject Ford F350 indicated damage primarily to the rear bumper, right rear bumper step pad, right tail lamp assembly, right tail lamp cover, right side bed panel, bed rear sill, right rear pillar, and required a pull to the right side bed with rear sill, which is consistent with the available photographs (Figure 1). According to Ms. Price's statement, there was denting and scraping to the right rear side and bumper on the subject Ford.

Figure 1: Photographs of the subject 2006 Ford F350

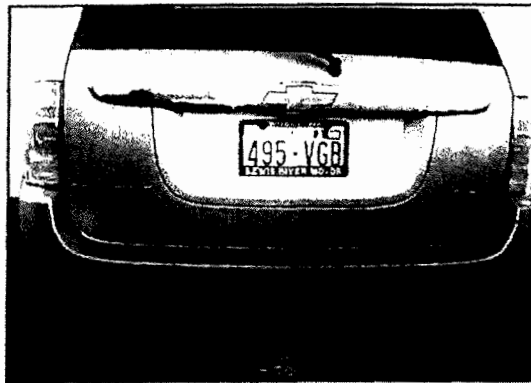
The damage estimate of the subject Chevrolet Equinox indicated damage primarily to the rear bumper cover and trailer hitch receiver cover plate, which is consistent with the reviewed photograph (Figure 1). The photograph depicted damage to the hitch plate cover; however, there was no significant indentation/crush to the rear of the subject Chevrolet. Ms. Christensen testified the "Chevy emblem thing" on the tow hitch was dented, and the rear bumper was scraped on the driver's side.

Figure 1: Reproduction of a photograph of the subject 2006 Chevrolet Equinox

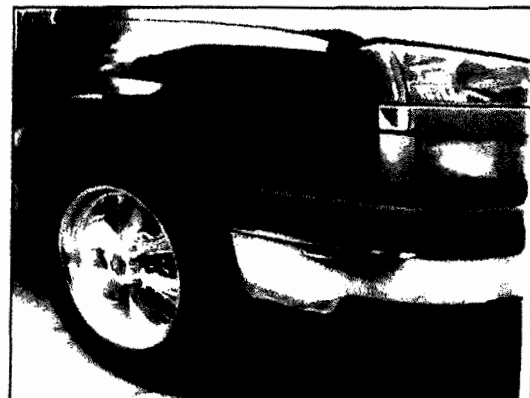
The damage estimate of the incident Chevrolet Silverado indicated damage primarily to the front bumper bar, which is consistent with the reviewed photographs (Figure 2). The photographs of the incident Chevrolet depicted a slight misalignment of the front face bar on the left side and damage to the license plate area.

Figure 2: Reproductions of photographs of the incident 2004 Chevrolet Silverado
